Orpheum Theatre Terra Cotta/Masonry Restoration

Hennepin Avenue
Minneapolis, Minnesota

Building Management Report

July 25, 2003

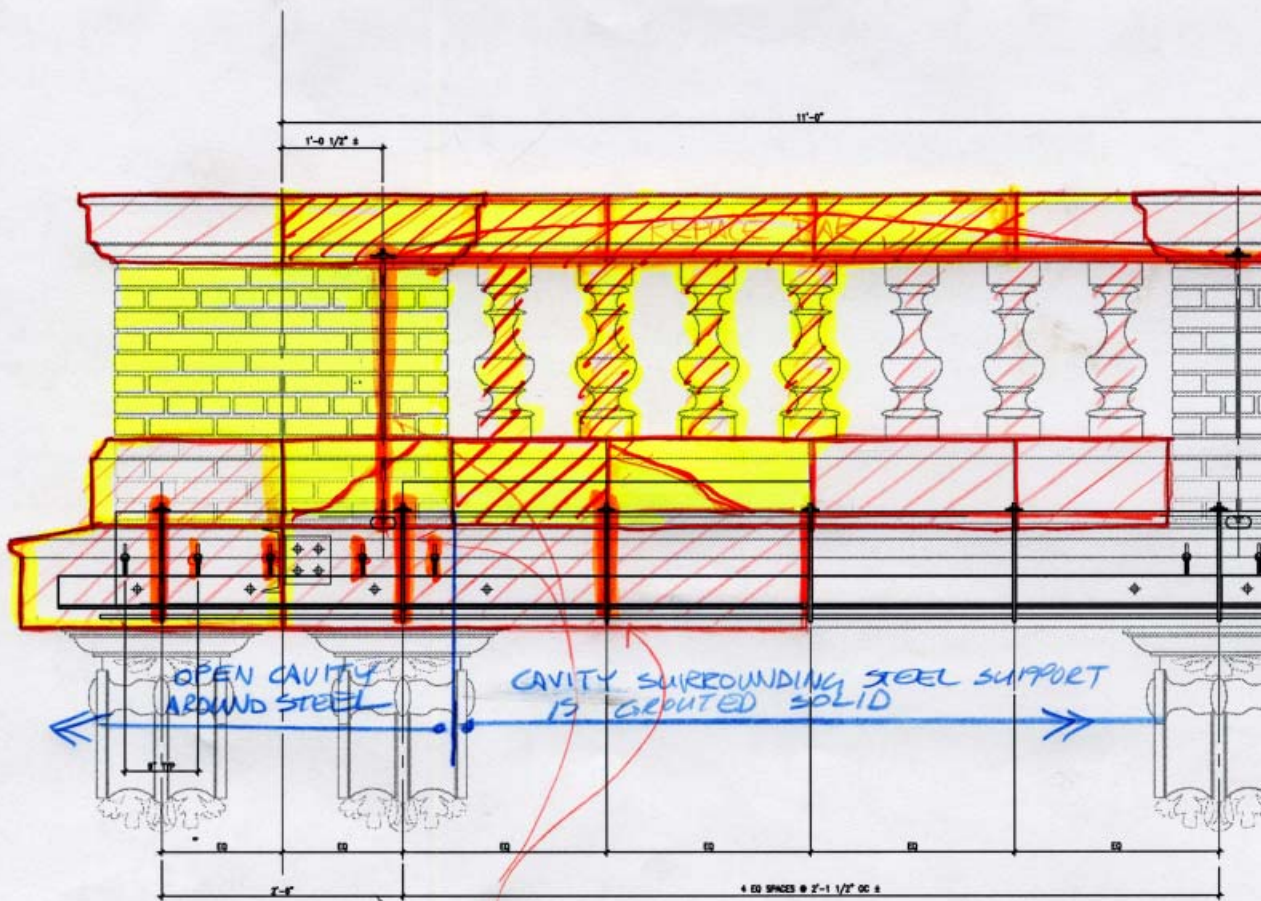
BAY 1

REMOVE VERTICAL RODS

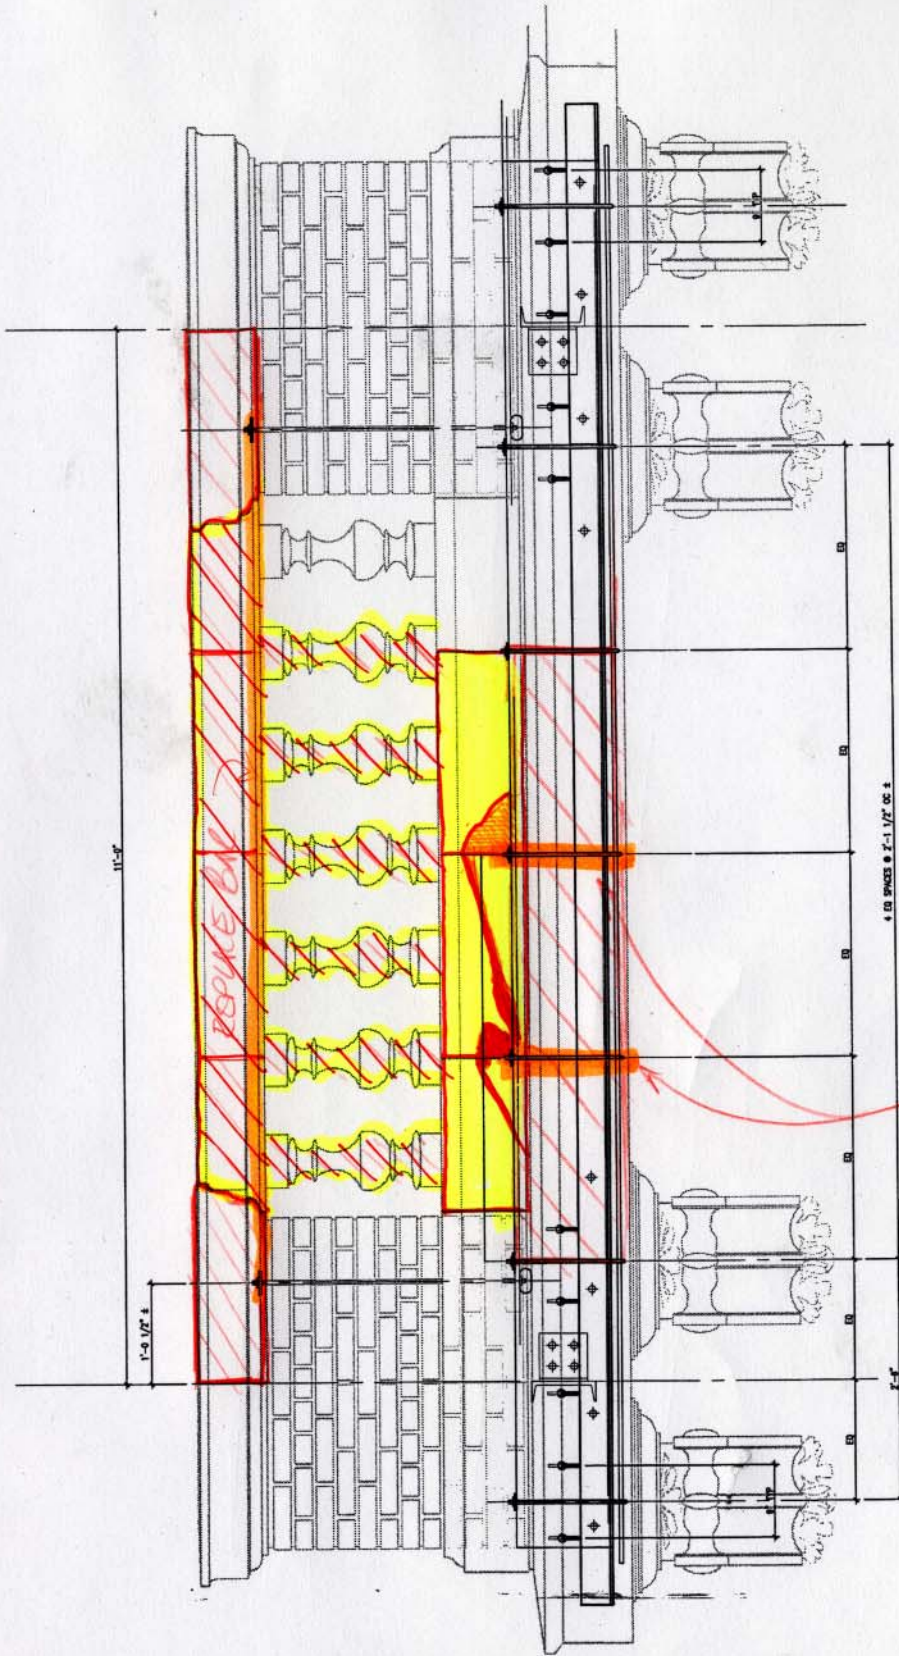
BAY 2

REMOVE VERTICAL RODS

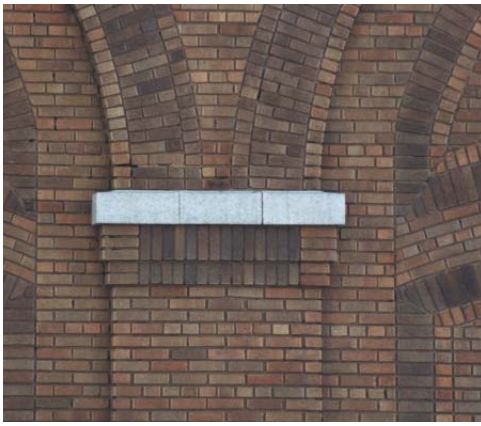
Fig.44: Impost block and masonry arch springers at the Hawthorne Avenue facade (From Detail 50.1/4-9)

This bay is at an early stage of deterioration. The joint at the structural steel support member, located two courses above the terra cotta band, is open. The terra cotta units appear to be intact but joints between units are open. There are many open brick masonry joints immediately below the terra cotta. Water is able to easily enter the wall system. Before long this bay will resemble conditions observed in Fig. 45.

Repair or replacement of steel in these areas potentially require extensive shoring, brick masonry removal, terra cotta removal and replacement, masonry reinstallation with some replacement, and repointing. Repairs of this magnitude exceed the scope of work and available budget for this phase. However, if no action is taken, degradation will proceed rapidly toward eventual failure. Obviously, delaying action now will necessitate more extensive repairs; damaged areas will increase in size and scope; more brick and terra cotta units will be involved in the repair/replacement process; steel may no longer be salvageable thereby forcing more extreme repair/replacement techniques. The bottom line is that the longer the damaged conditions are left untreated, more historic material will be lost in the interim, and significantly higher associated repair costs will be incurred in the future.

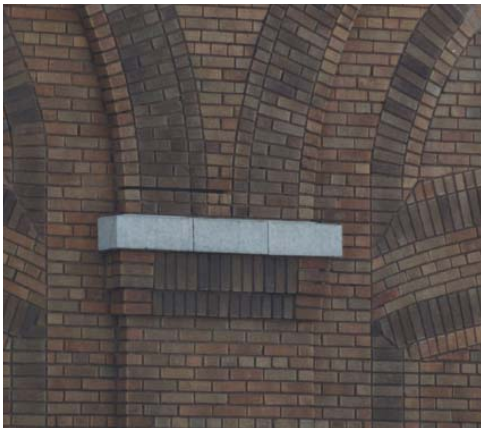
Fig.45: Impost block and springer @ Hawthorne Avenue facade (From Detail 58.1/4-9)

This bay is starting to show more advanced signs of deterioration. The joint at the structural steel support member is open. One terra cotta unit is cracked and joints between units are open. There are many open brick masonry joints immediately below the terra cotta. Again, water is able to easily enter the wall system. Corroding steel anchors are expanding thus causing damage to nearby terra cotta. Before long this bay will resemble conditions observed in Fig. 46.

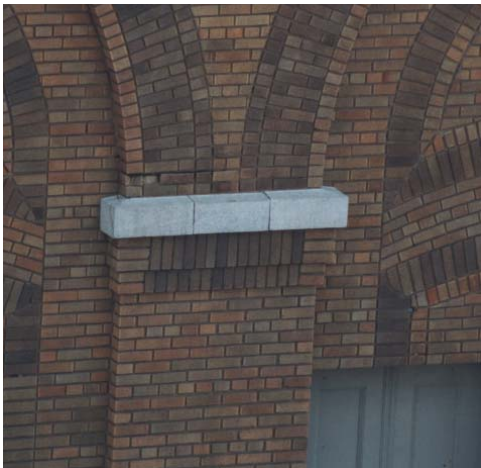
Fig.46: Impost block and springer @ Hawthorne Avenue facade (From Detail 48.1/4-9)

Damage to this bay is severe. The joint at the structural steel support member is open and the corroded steel member is clearly visible. Several bricks above the terra cotta band are crushed. The adjacent terra cotta unit is severely cracked and the fragmented piece threatens to dislodge and fall to the sidewalk below. The joints between terra cotta units are open and the units appear to be misaligned indicating possible anchorage failure. From this point forward, deterioration will advance rapidly and soon this bay will resemble conditions observed in Fig. 47.

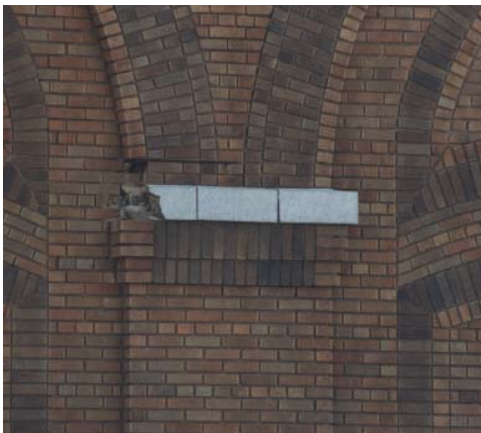
Fig.47: Impost block and springer @ Hawthorne Avenue facade (From Detail 58.1/4-9)

This bay is well on its way to becoming a potential life safety hazard. The joint at the structural steel support member is open and the corroded steel member is clearly visible. There appears to be substantial delamination and deformation of the steel member. Several bricks above the terra cotta band are missing. The adjacent terra cotta unit is shattered. The joints between terra cotta units are open and the units are obviously displaced indicating possible anchorage failure. Deterioration at the exposed section will continue to accelerate, ultimately affecting the surrounding materials.
